# Designing Living Shorelines for Sea Level Rise in Virginia:

## A Resource for Practitioners

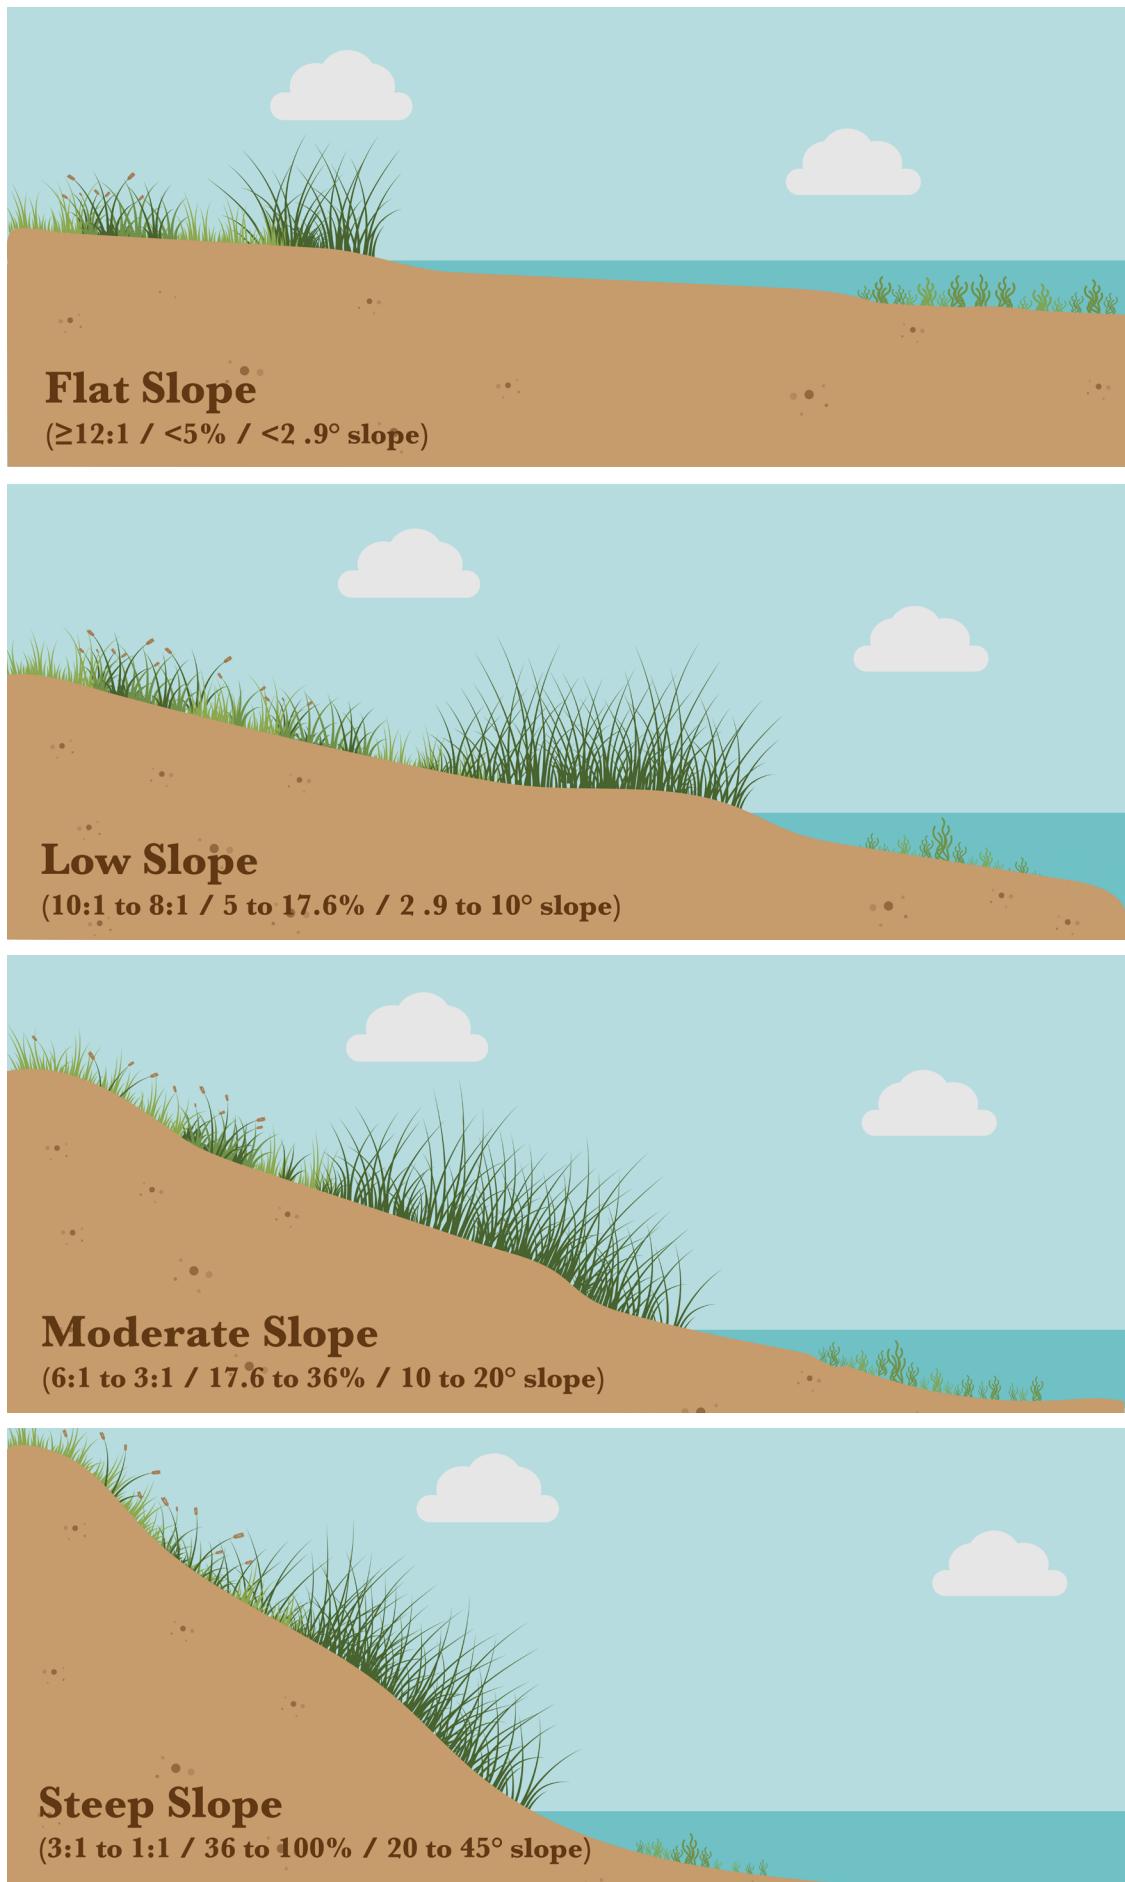
Figure 1. Shoreline slope classifications for flat, low, moderate, and steep slopes. Very steep slopes ( $>45$  degrees) are not depicted in this figure.

The shoreline's slope is a critical factor in determining whether wetland flora and fauna can migrate landward. Landward, upslope migration helps protect wetlands and sensitive coastal habitats from the impacts of sea level rise. Slope is a strong indicator of erodibility and stability of the shoreline and bank. Living shoreline designs should endeavor to create the most gradual, and therefore stable, slope possible for a particular site. Creating a gradual slope from the water's edge to the top of the bank creates the most favorable conditions for marsh migration. However, the slope that can be achieved will be determined by existing site conditions and limitations. While the recommended slope for the shore is 10:1 (Hardaway et. al., 2021), other research suggests that wetlands migration and stability may occur at slightly steeper slopes on the backshore and bank. Slopes can be classified as Flat (<5% / <2 .9 degrees slope), Low Slope (5-17.6% / 2.9 -10 degree slope), Moderate Slope (17.6% - 36% / 10-20 degree slope), Steep Slope (36-100% / 20 to 45 degree slope) and Very Steep Slope (>45 degrees) (see Figure 1 below). These categories are based on literature (Molino et al., 2021), and the ShoreWatch App developed by the Center for Coastal Resource Management at VIMS.

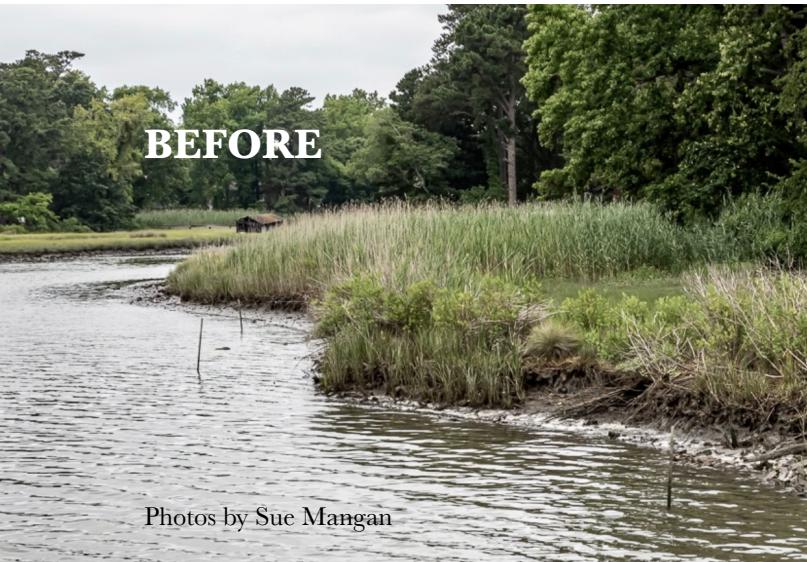
**BEFORE**

*Solution:* Installing silt fencing at the base of the four-foot incline, placing loose oyster shells in the gaps between oyster castles, and planting a buffer between the backshore incline and the shoreline.

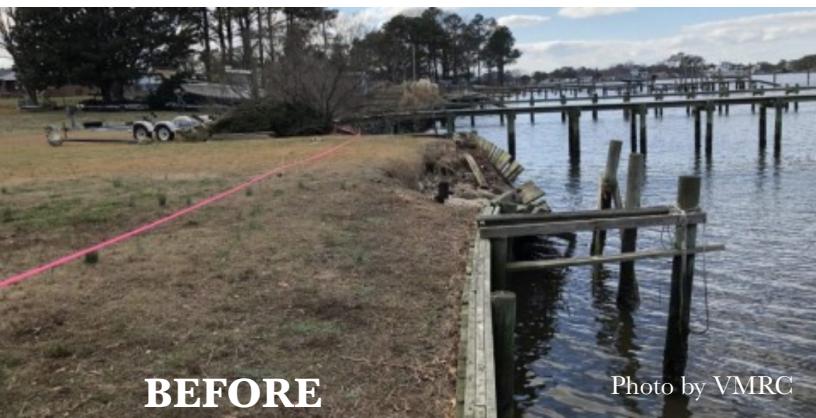
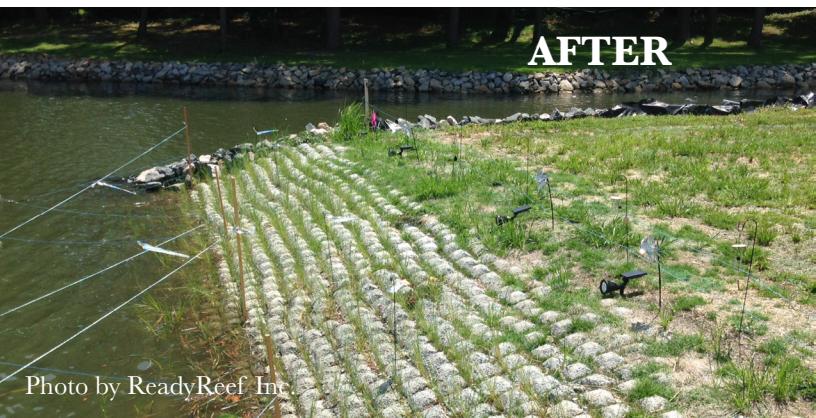
The project involves removal of an existing dilapidated bulkhead and replacement with a new living shoreline utilizing a flexamat (concrete mat) with integrated wetland plantings suitable for site conditions. The wetlands have grown through the flexamat structure, giving the appearance of a naturally vegetated living shoreline.

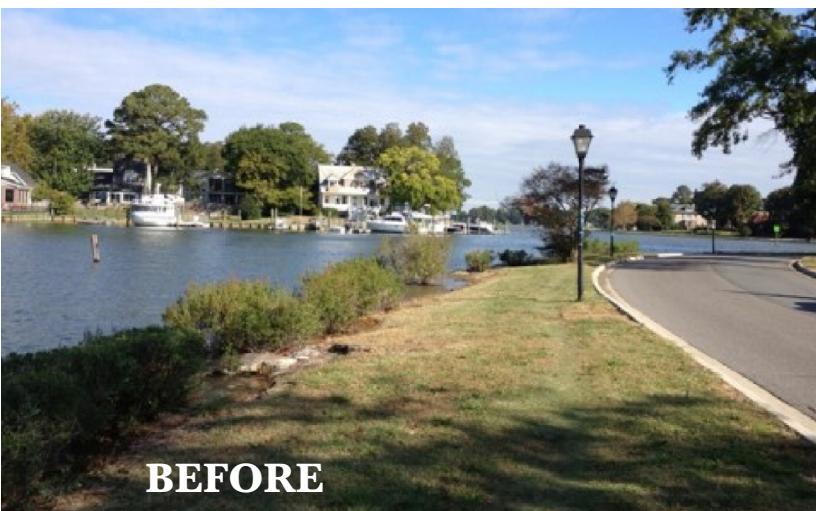
**BEFORE**

The purpose of the project is to improve the eroding shoreline. This will be accomplished by removing the remaining pieces of derelict timber bulkhead and constructing a section of bulkhead to stabilize an improved outfall pipe, sections of revetment, and a section of living shoreline.

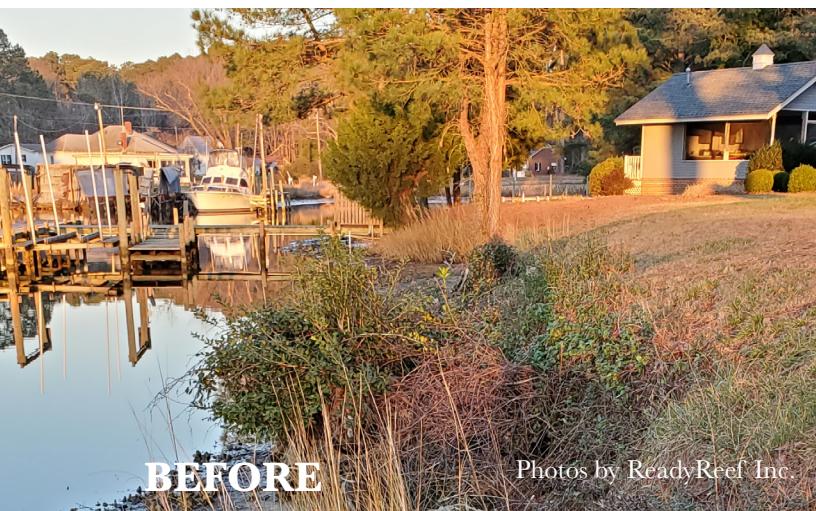
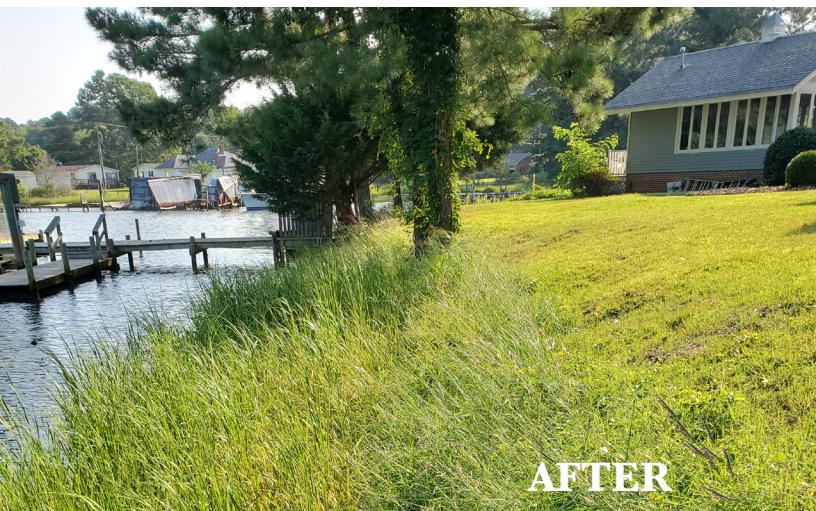
The primary purpose of the project is to prevent erosion from sea level rise and the secondary purpose is to enhance habitat through oyster habitat and wetlands grasses. The project placed 144 ft of 1 ft high Ready Reefs as a sill, backfilled with clean sand on a 10:1 slope, and planted with 1240 sq ft *Sporobolus alterniflorus* along the eroding shoreline. All of this work was above MLW. The reefline will extend 18 sq feet seaward of MLW. Additionally, Envirolok bags will be stacked up close to the bank for erosion control, extending up to the lawn edge for a total of 195 linear feet of bank. *Sporobolus pumilus* will be planted in the 471 sq ft of bag face.

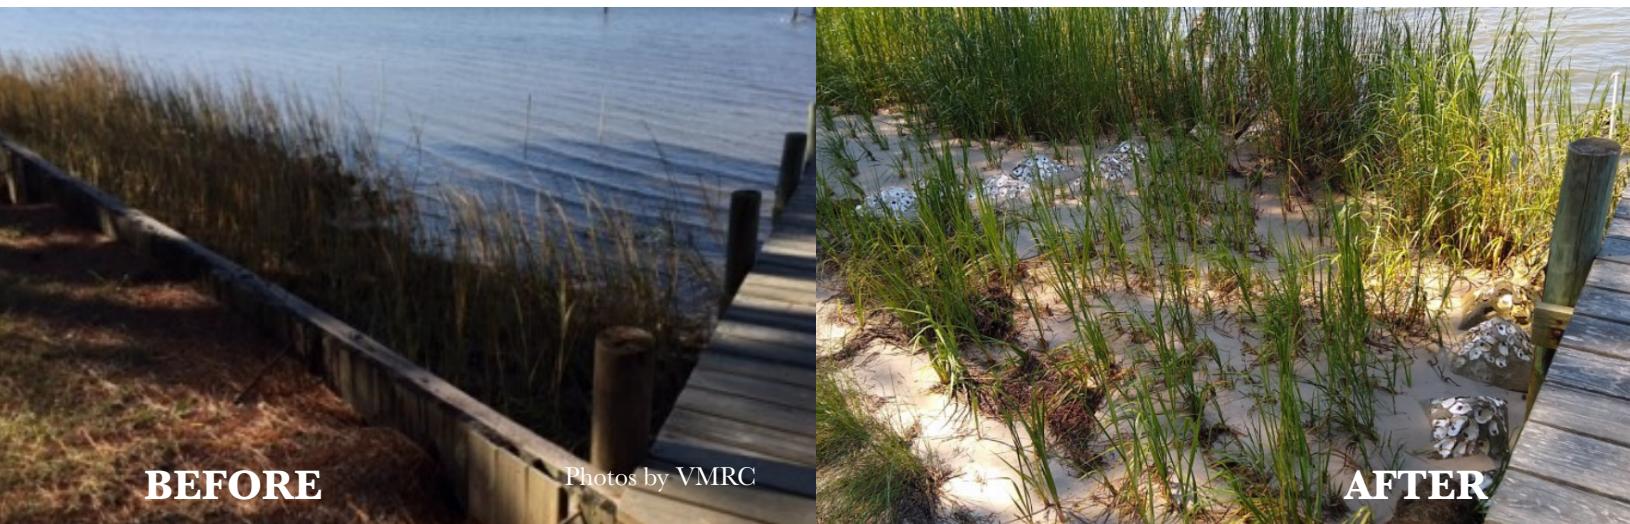
Cross Section A-A

Off-shore Sill and Sand Backfill  
Alternaria from Half tide elevation to MHW  
S. Patens from MHW to 1.5x Tide

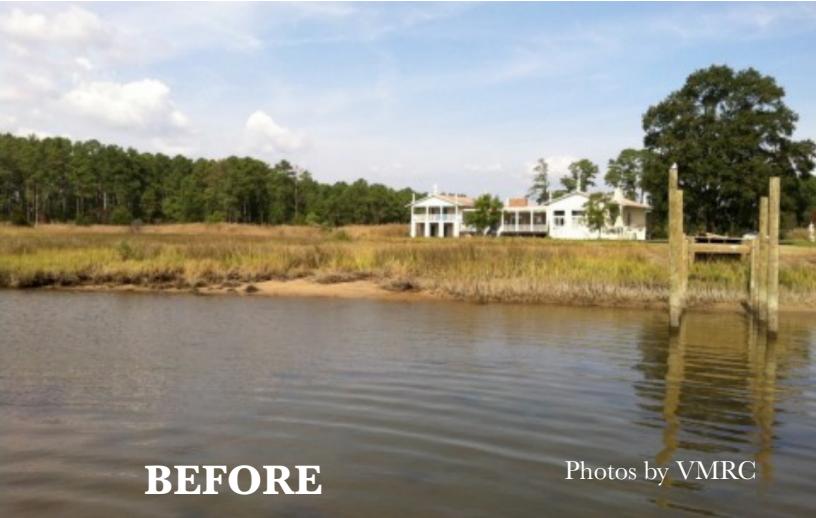
**BEFORE**

Marsh edge erosion was stabilized with stone sills, sand fill and planted salt marsh that tied into the natural marsh. This is a public demonstration project.

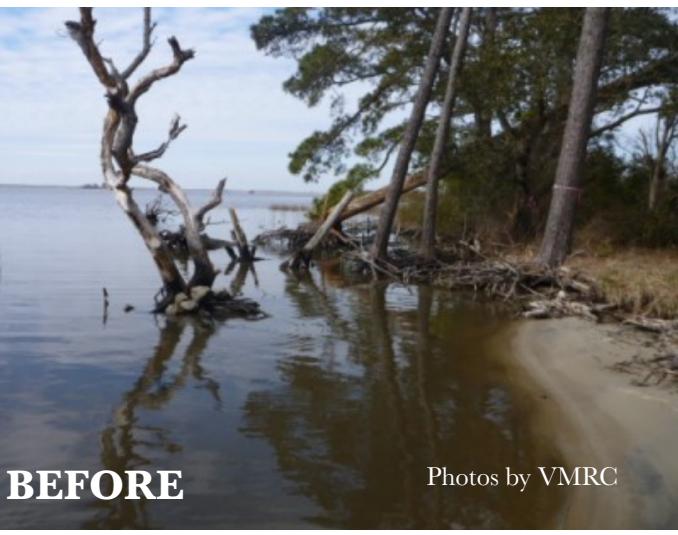
**BEFORE**

Three projects at Barbours Hill, Spratts Cove, and the Education Center with the primary purpose being to stabilize eroding sections of shoreline through the use of living shoreline techniques for protection of public infrastructure and assets. Two sites include the installation of class 1 rock sills (approx. 12 ft wide, 3 ft high), sand fill, and native coastal/buffer plantings. The remaining site, a primary access road, involves raising the elevation of the roadway to avoid overtopping, and replacement of a failed culvert pipe. The secondary purpose is achieving the goals of the park to protect and provide natural resources by reducing sedimentation to Back Bay, improving water quality and habitat for aquatic animal and plant species, and promoting establishment and presence of submerged aquatic vegetation.

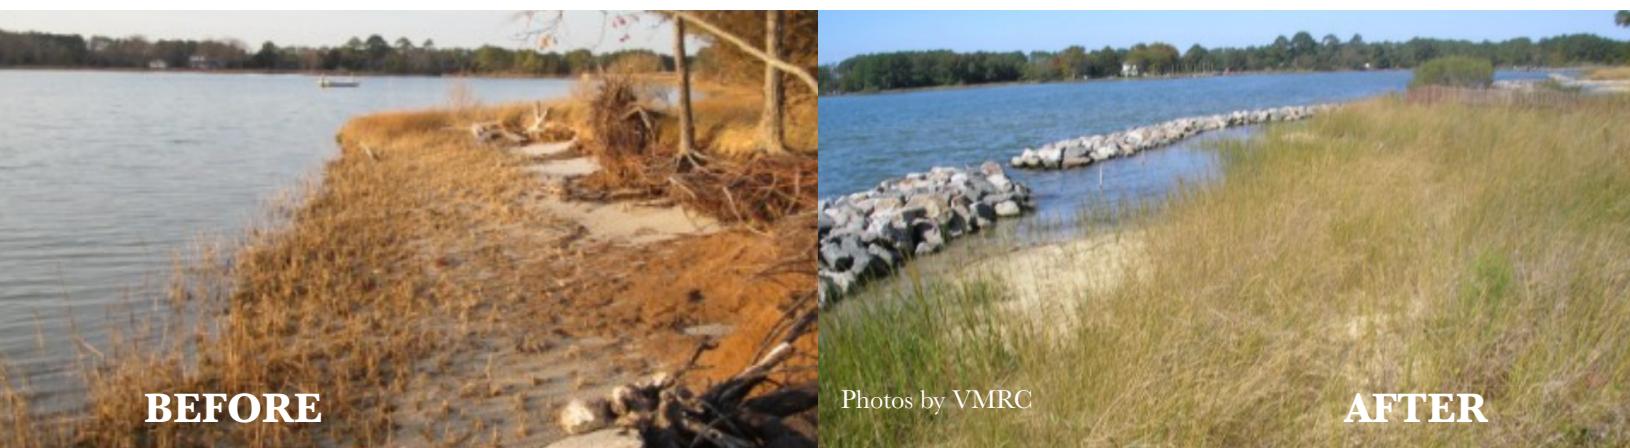
# Occohannock on the Bay

Living shoreline project with 6,900 sq ft of low marsh and 9,120 sq ft of high marsh and 3 distinct treatment sections:

- 1) Approx 405 ft of cobble sill to protect and enhance the existing high marsh fringe which was actively eroding along the water's edge. This marsh is partially protecting the adjacent upland from moderate storm waves. Portions of the low upland bank were eroding as the fringe became narrower.
- 2) Approx 185 ft of stone revetment to protect actively eroding upland and access path.
- 3) Approx 480 ft of stone sill consisting of sill units.

Site Condition	Pre-Construction	Post-Construction
Slope	Steep	Steep
Bank Height	High	High (Various; 5-12 ft, MLLW, +9, 120 sq ft)
Low Marsh	Eroded	Stable (+1.7 ft MLLW, +6,900 sq ft)
High Marsh	Transitional	Stable (+4.4 ft MLLW)
Buffer Condition	Vegetated	Vegetated
Shore Width	Wide	Wide
