Project: Legacy Blvd. Intersection

Subject: Victory Blvd Speed Study

The purpose of this memo is to summarize the speed data collected for Victory Blvd (State Route 171) in the City of Poquoson, Virginia. The city recently installed a new traffic signal at the intersection of Legacy Blvd and Victory Blvd. The posted speed limit along Victory Blvd changes from 55 mph through the intersection at Legacy Blvd, to 35 mph approximately 225-ft east of the intersection, without speed transition zone signs posted. This memo reviews the speed data collected to determine if the posted speed limits are appropriate and provide countermeasure recommendations, if warranted.

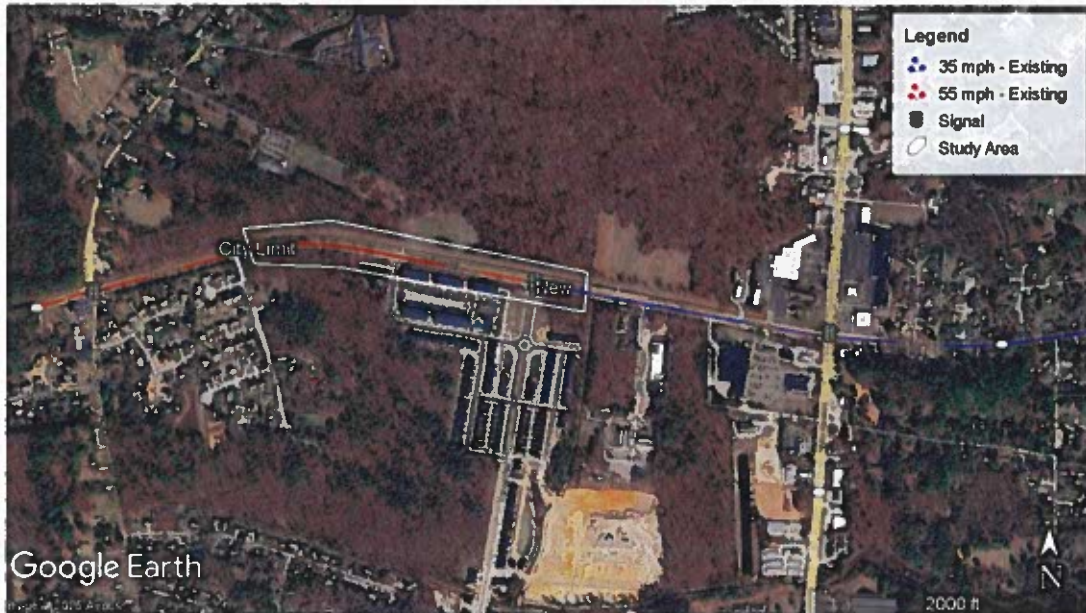
Figure 1- Victory Blvd Study Area

Victory Blvd is a minor arterial with a posted speed limit of 55 mph west from the city line to approximately 225-ft east of Legacy Blvd where the posted speed limit is 35 mph as the corridor transitions to a more urban environment. The 55 mph speed limit along Victory Blvd was established outside of city limits by resolution on 12/17/1975 and continues through Legacy Blvd. In existing conditions, Victory Blvd is a two-lane undivided roadway with paved 10-ft shoulders for the eastbound direction, and 1-ft paved shoulders and 40-ft cleared grass shoulder for the westbound direction. A study area map showing is shown in Figure 1.

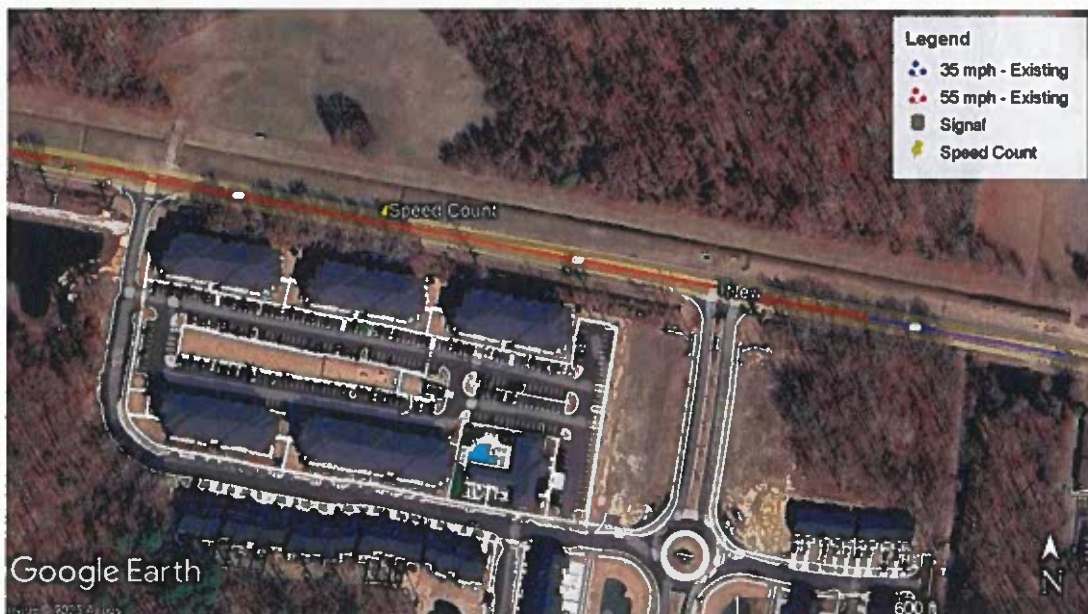
Figure 2- Location of Speed Counter on Victory Blvd

Daily directional counts and speed data were collected for 48 hours from Tuesday, June 3, 2025 at 12:00AM, through Thursday June 5, 2025 at 12:00 AM on Victory Blvd approximately 600-ft west of Legacy Blvd within the 55 mph speed zone, as seen in Figure 2.

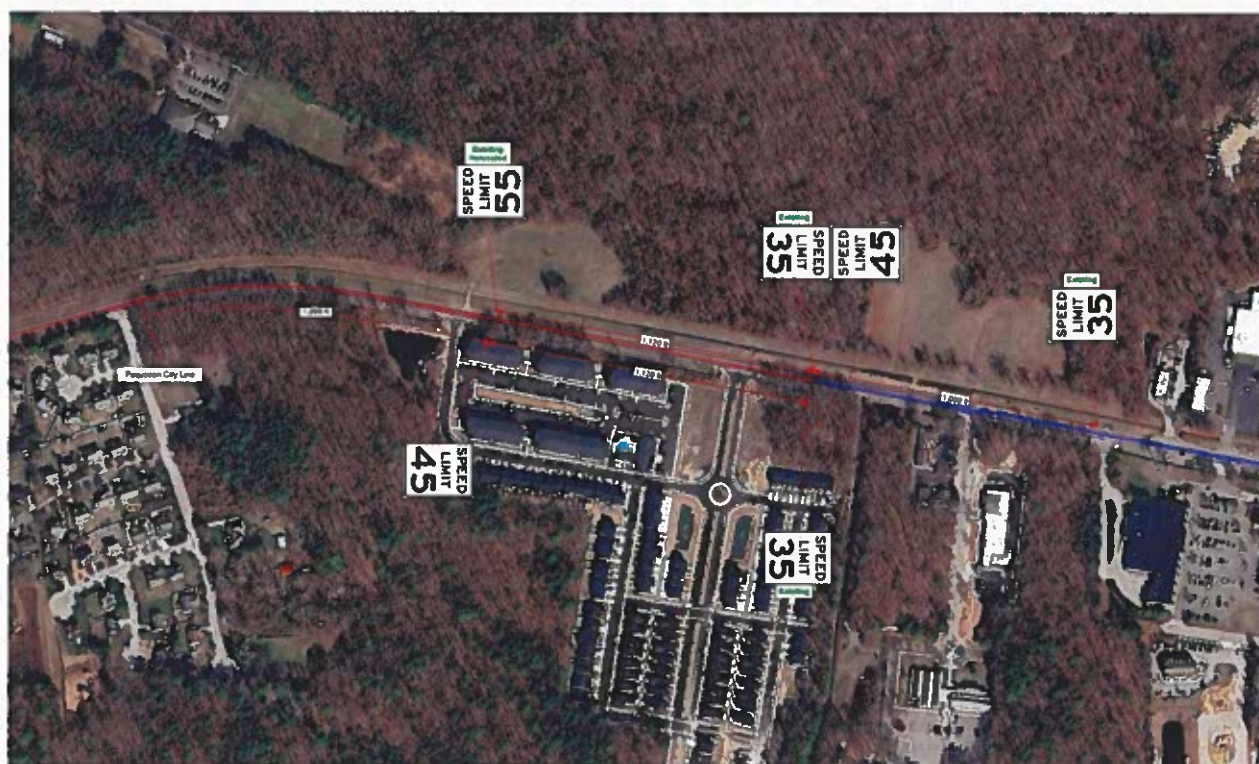
Figure 4- Recommendations

According to the speed study and the traffic count that was conducted, the average speed for both directions reached a max of 46.0 mph with a daily traffic volume of over 13,000 vehicles per day. The crash analysis did not indicate severe safety concerns and with a posted speed of 55 mph, this should not be a cause of concern. However, since there are no existing advanced warning signs indicating the 20 mph speed reduction, it is recommended to implement a transition zone by introducing a 45 mph posted speed limit zone in advance of the existing 35 mph posted speed zone. Additionally, with the traffic signal pole foundation located within a 55 mph clear zone, and the new traffic signal and adjacent development effectively marking the beginning of a more urban environment, reducing the speed to 45 mph in this area would better align with the surrounding roadside development and serve as a gateway into the city. Recommended locations of new posted speed limit signs are shown in Figure 4.
